10694 Haddington Drive Thermal Roof Report

10694 Haddington Drive

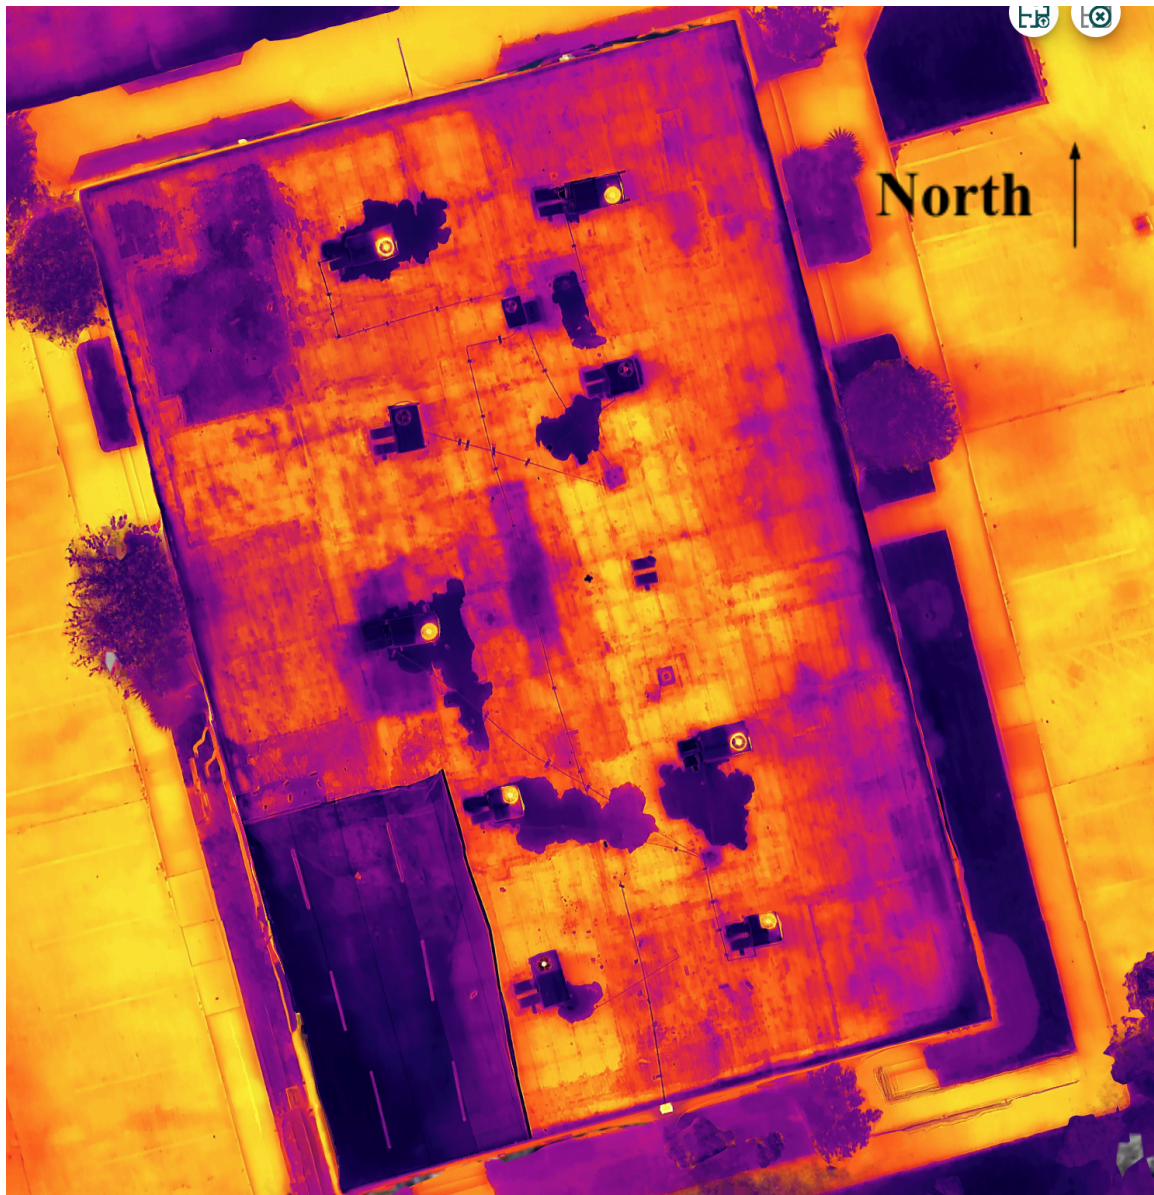
Above is a 2D thermal map of the roof. This map is comprised of 241 individual photos that have been stitched together to create a complete map of the roof overlaid with thermal information.

Prior to evaluating the following inspection photos, this map provides a comprehensive look at the condition of the roof in its entirety in terms of suspected moisture intrusion.

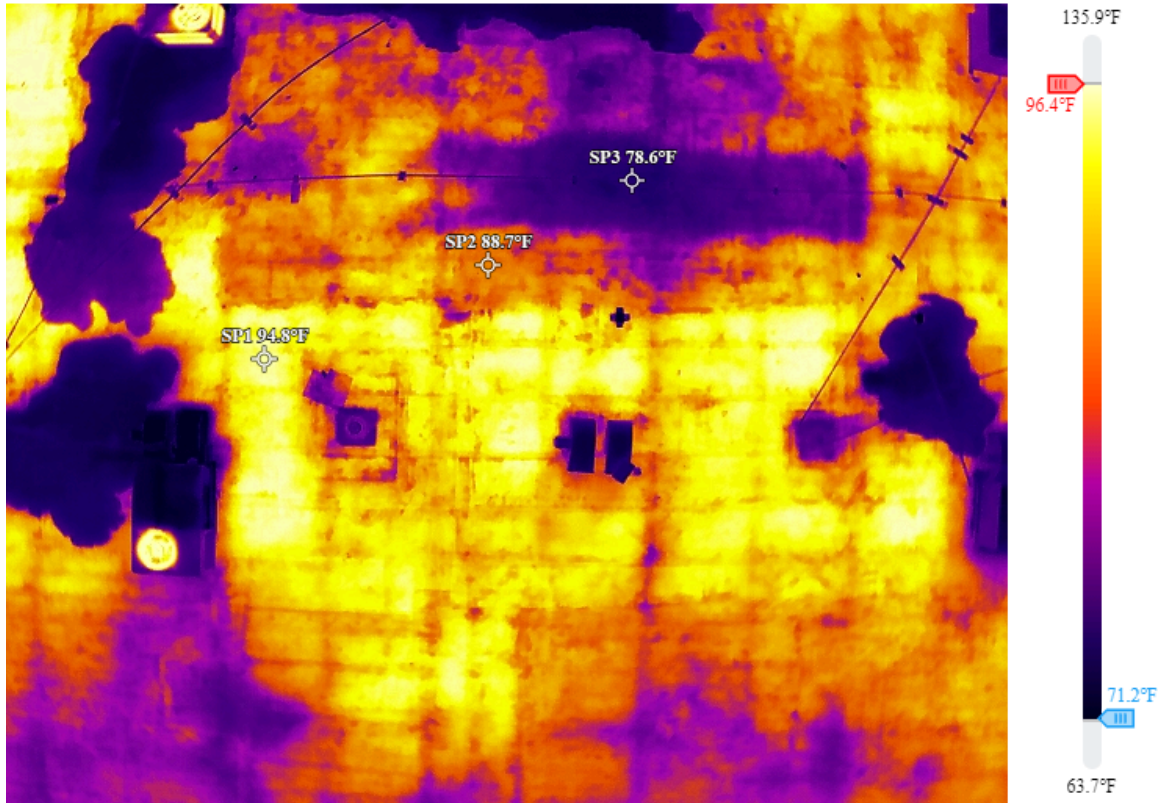
Central.JPG

SP1	VALUE	94.8°F
SP2	VALUE	88.7°F
SP3	VALUE	78.6°F

KEY	VALUE
SP1	Most moisture
SP2	Moderate moisture
SP3	Least moisture

Majority of suspected moisture intrusion is concentrated in central portion of roof

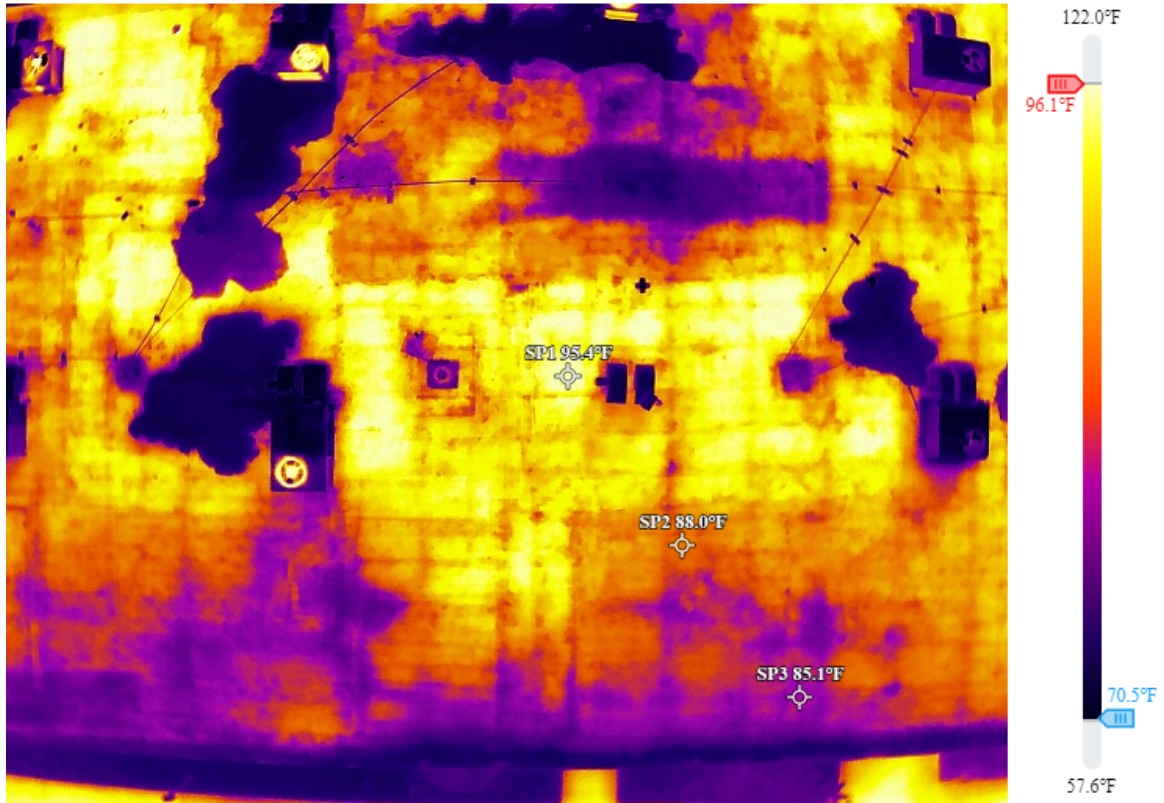
East.JPG

SP1	VALUE	95.4°F
SP2	VALUE	88.0°F
SP3	VALUE	85.1°F

KEY	VALUE
SP1	Most moisture
SP2	Moderate moisture
SP3	Least moisture

Cooler-colored area along eastern portion of roof (bottom of photo) indicates what appears to be a lack of water intrusion

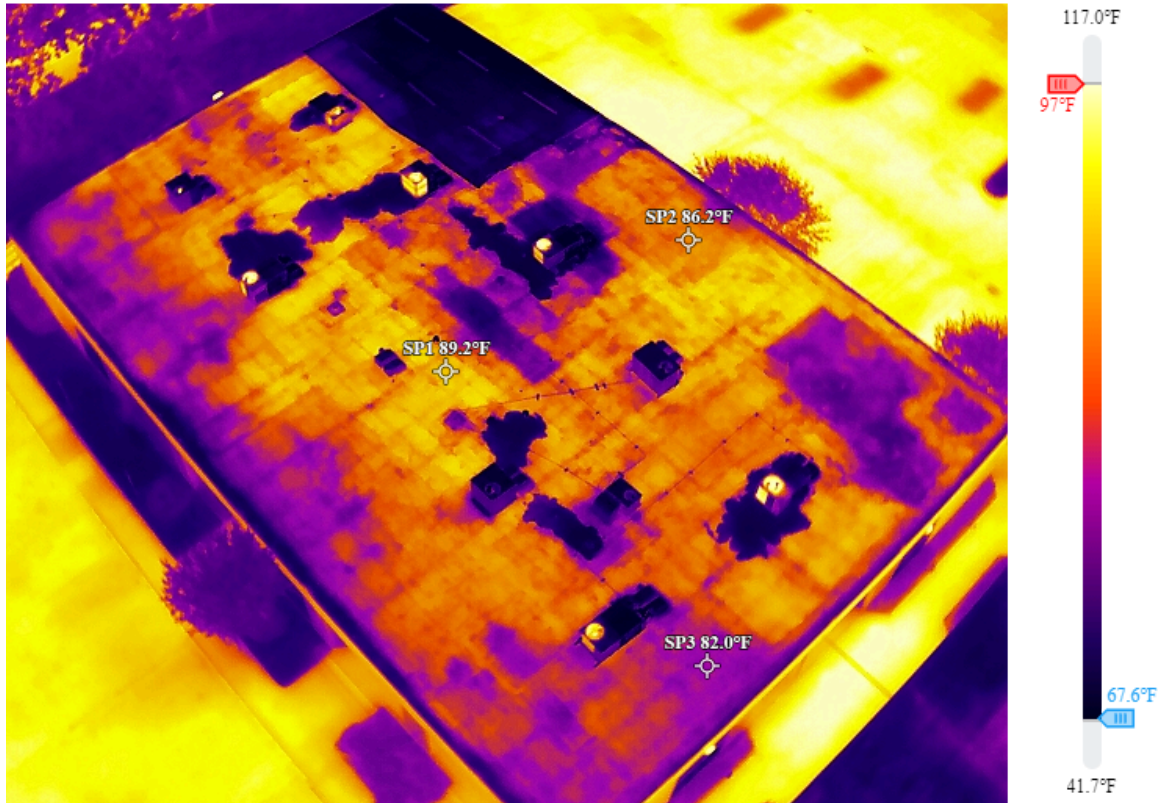
Northeast Whole.JPG

SP1	VALUE	89.2°F
SP2	VALUE	86.2°F
SP3	VALUE	82.0°F

KEY	VALUE
SP1	Most moisture
SP2	Moderate moisture
SP3	Least moisture

Eastern portion of roof perimeter appears to have minimal moisture than the majority of surrounding roof areas

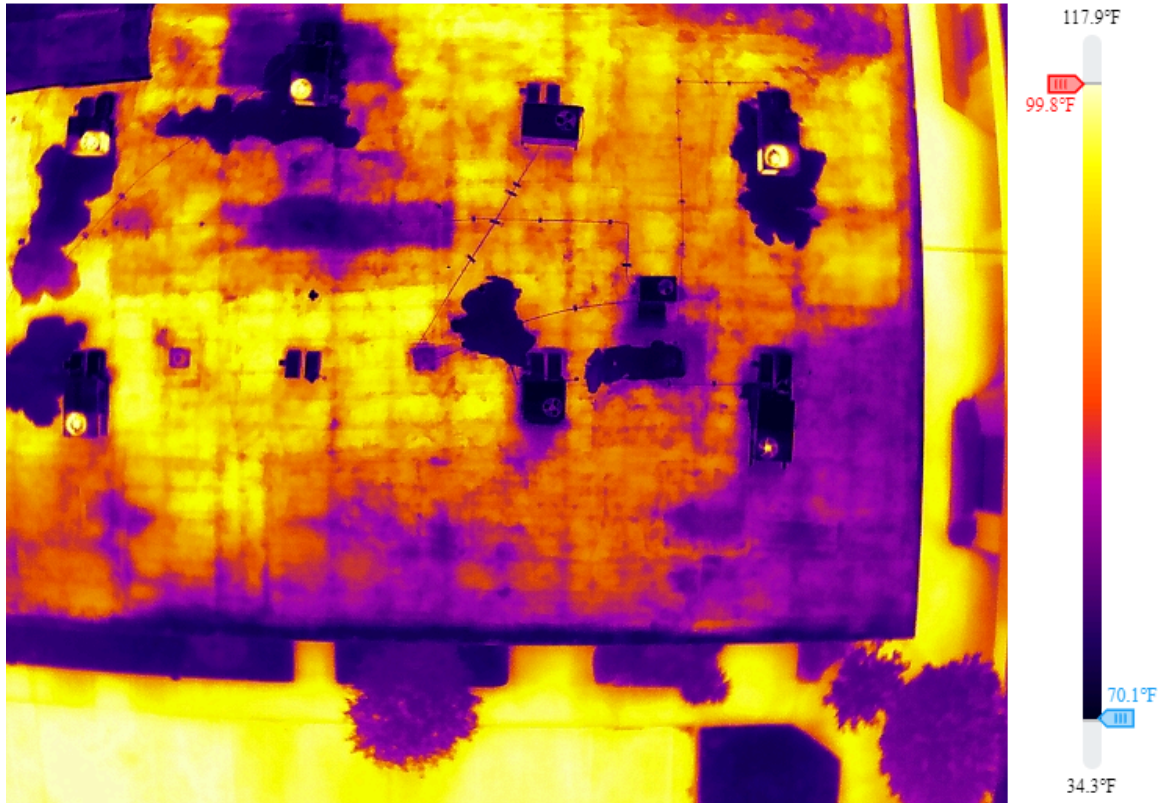
Northeast.JPG

Northwest corner appears to have minimal moisture

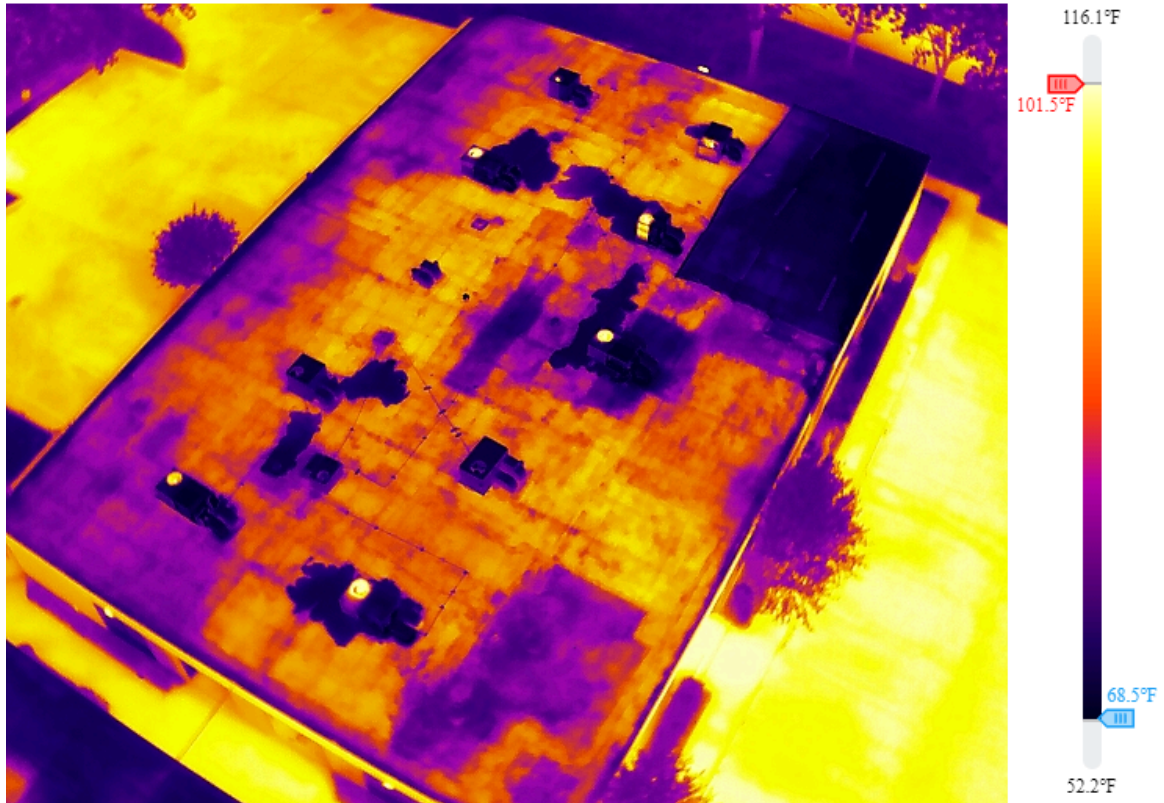
Northwest Whole.JPG

Most of northwest corner appears to have minimal moisture with exception of the far western edge

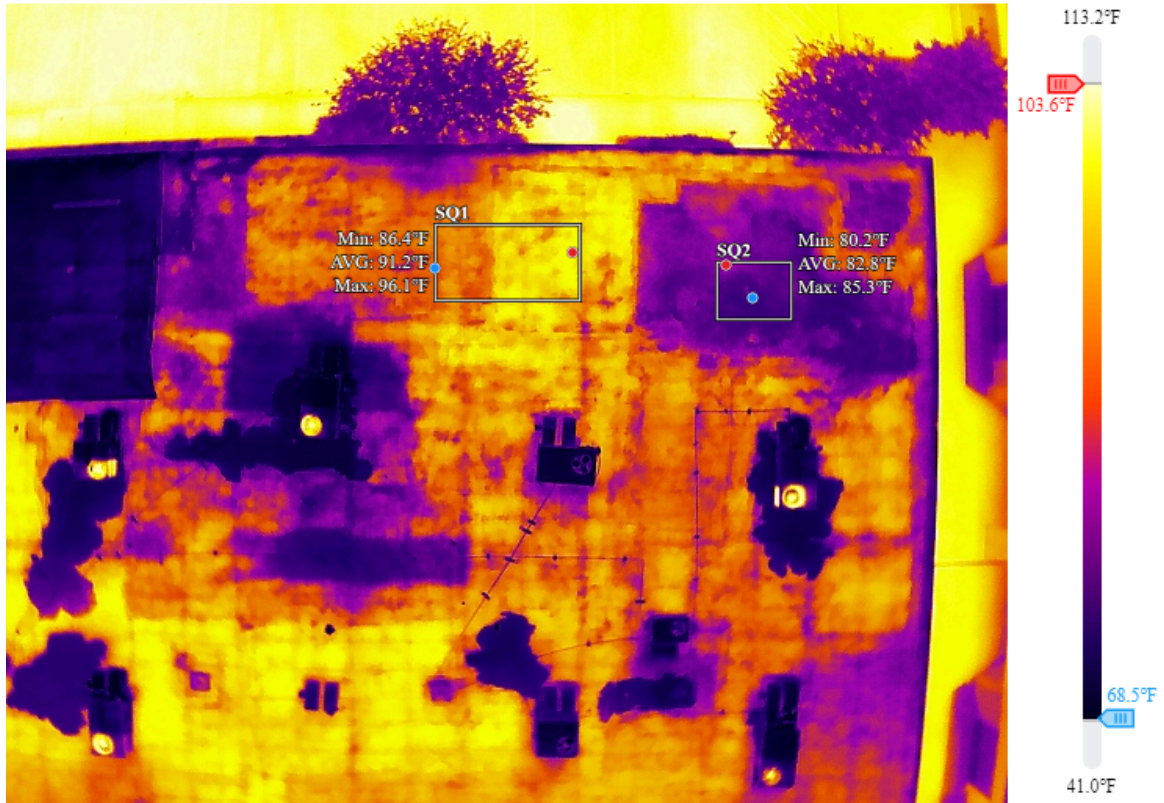
Northwest.JPG

SQ1	MIN	86.4°F
	AVERAGE	91.2°F
	MAX	96.1°F
SQ2	MIN	80.2°F
	AVERAGE	82.8°F
	MAX	85.3°F

KEY	VALUE
SQ1	Moisture affected
SQ2	Not moisture affected

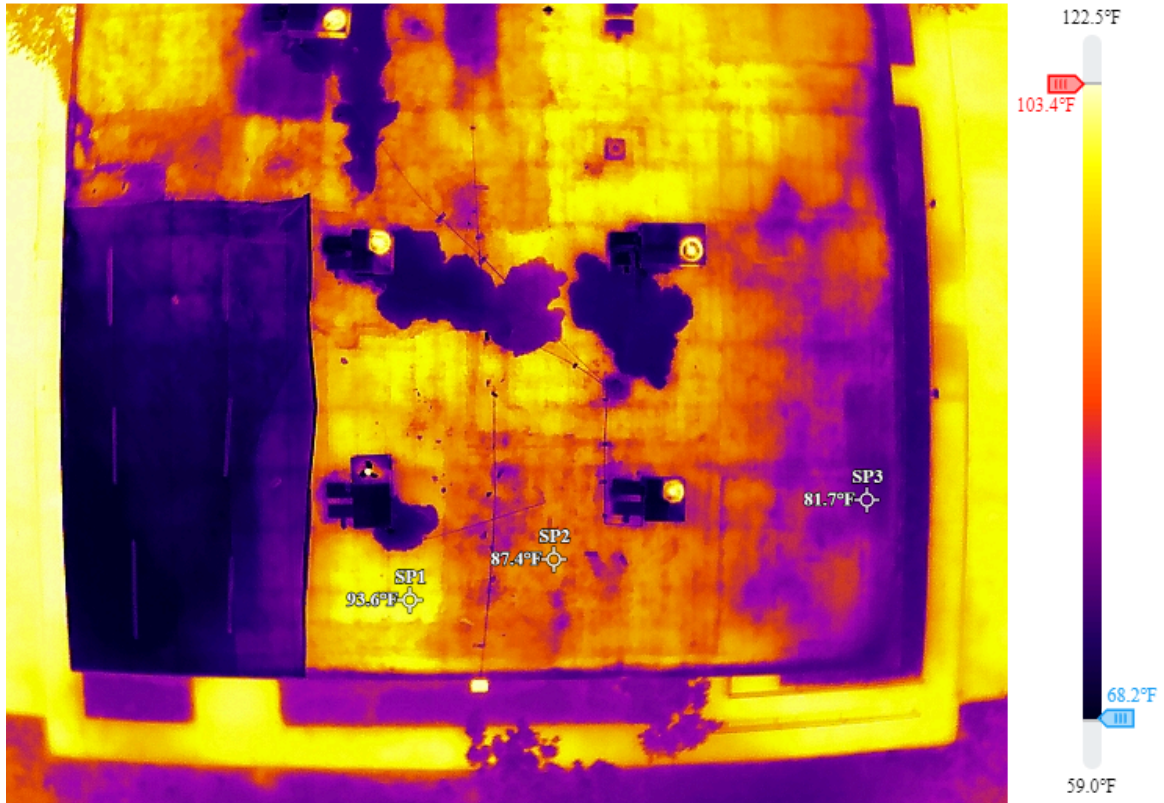
South.JPG

SP1	VALUE	93.6°F
SP2	VALUE	87.4°F
SP3	VALUE	81.7°F

KEY	VALUE
SP1	Most moisture
SP2	Moderate moisture
SP3	Least moisture

Cool area at southwest corner appears to be tarp (likely covering severely moisture damaged area)

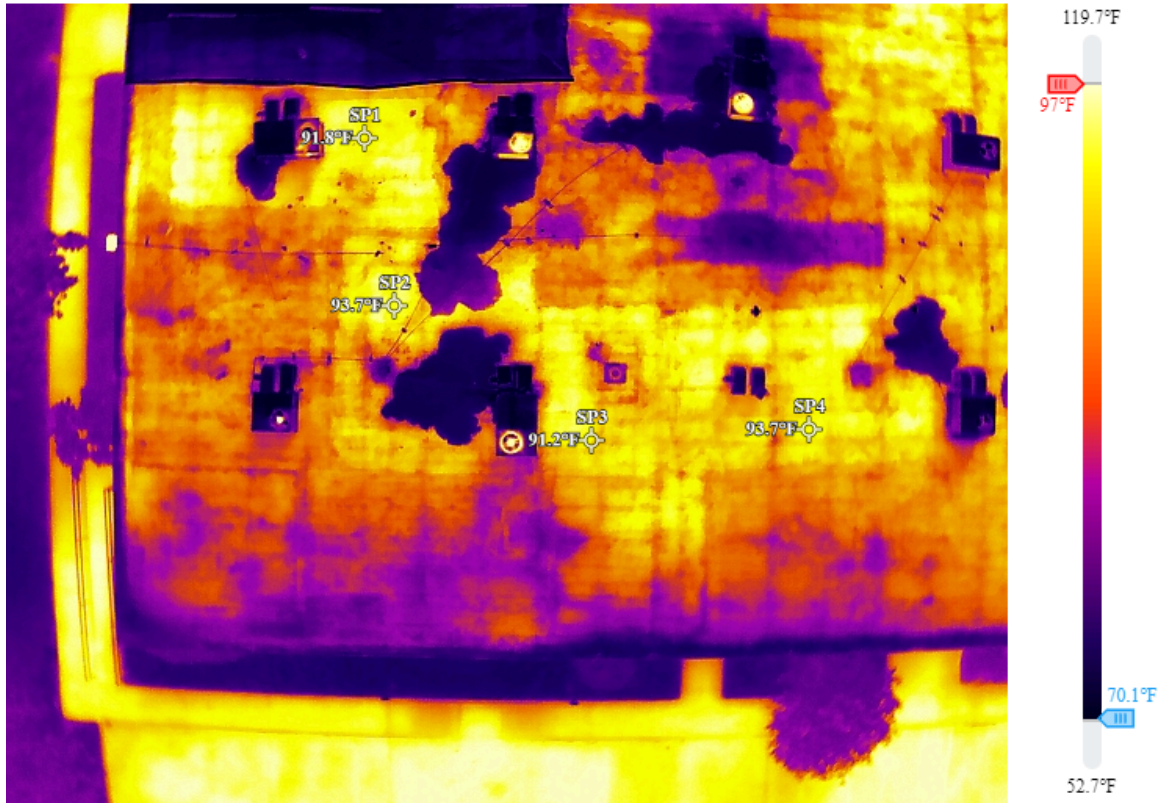
Southeast.JPG

SP1	VALUE	91.8°F
SP2	VALUE	93.7°F
SP3	VALUE	91.2°F
SP4	VALUE	93.7°F

KEY	VALUE
SP1	Moisture affected
SP2	Moisture affected
SP3	Moisture affected
SP4	Moisture affected

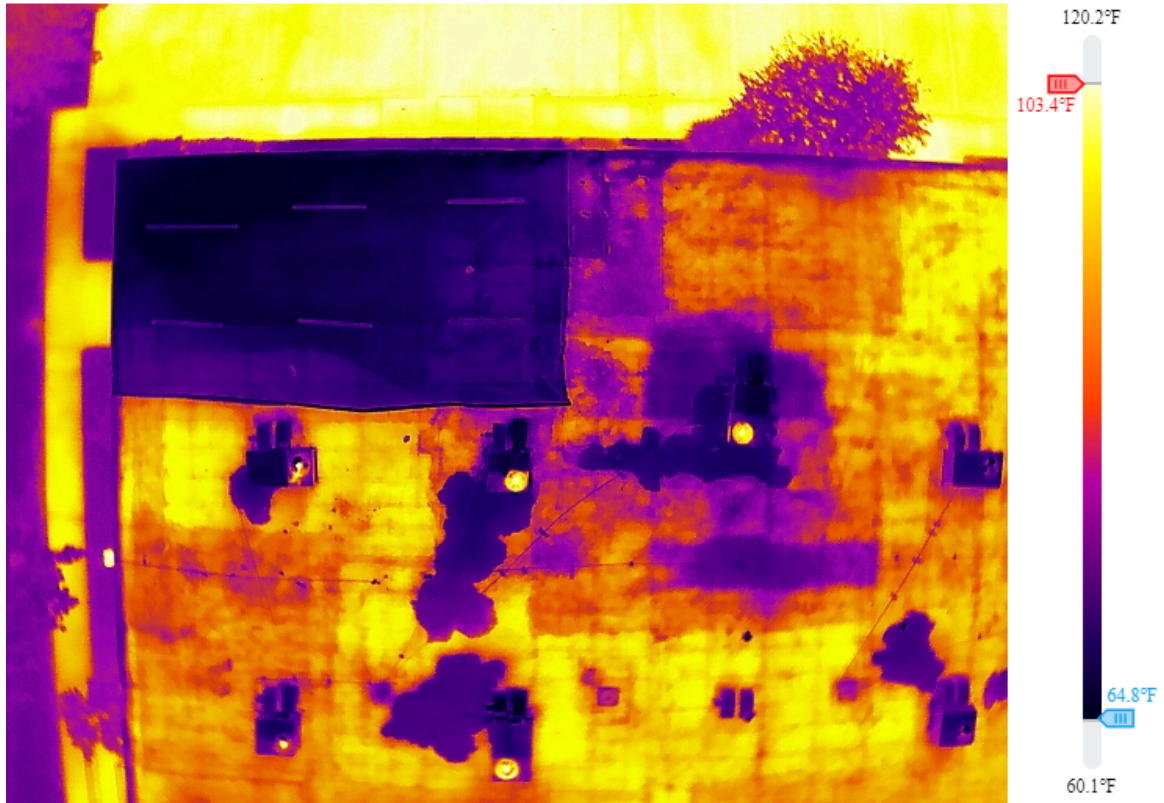
Southwest.JPG

Cool area at southwest corner appears to be tarp (likely covering severe moisture damaged area)
