Chenault Drive Thermal Roof Report

Environmental Conditions During Inspection

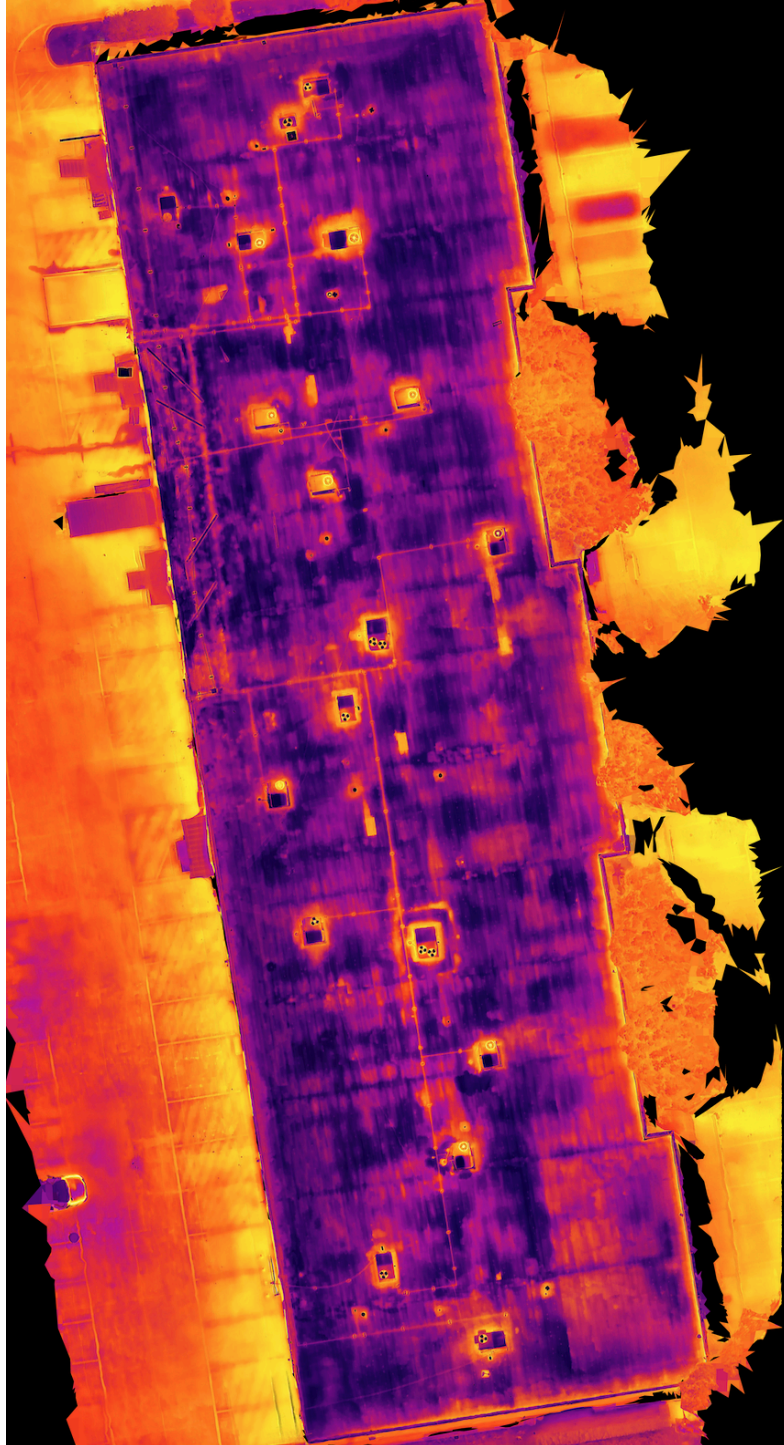
The thermal data indicates suspected water ingress concentrated along all edges of the roof. There also appears to be moisture concentrated primarily in the southern and eastern portions of the roof, with a fair amount being visible around other portions of the north end of the roof. The western edge of the roof shows signs of suspected moisture ingress co-located with an area of obvious visible roof damage.

Above is a 2D thermal map of the roof. This map is comprised of 300 individual photos that have been stitched together to create a complete map of the roof overlaid with thermal information.

Prior to evaluating the following inspection photos, this map provides a comprehensive look at the condition of the roof in its entirety in terms of suspected moisture intrusion.

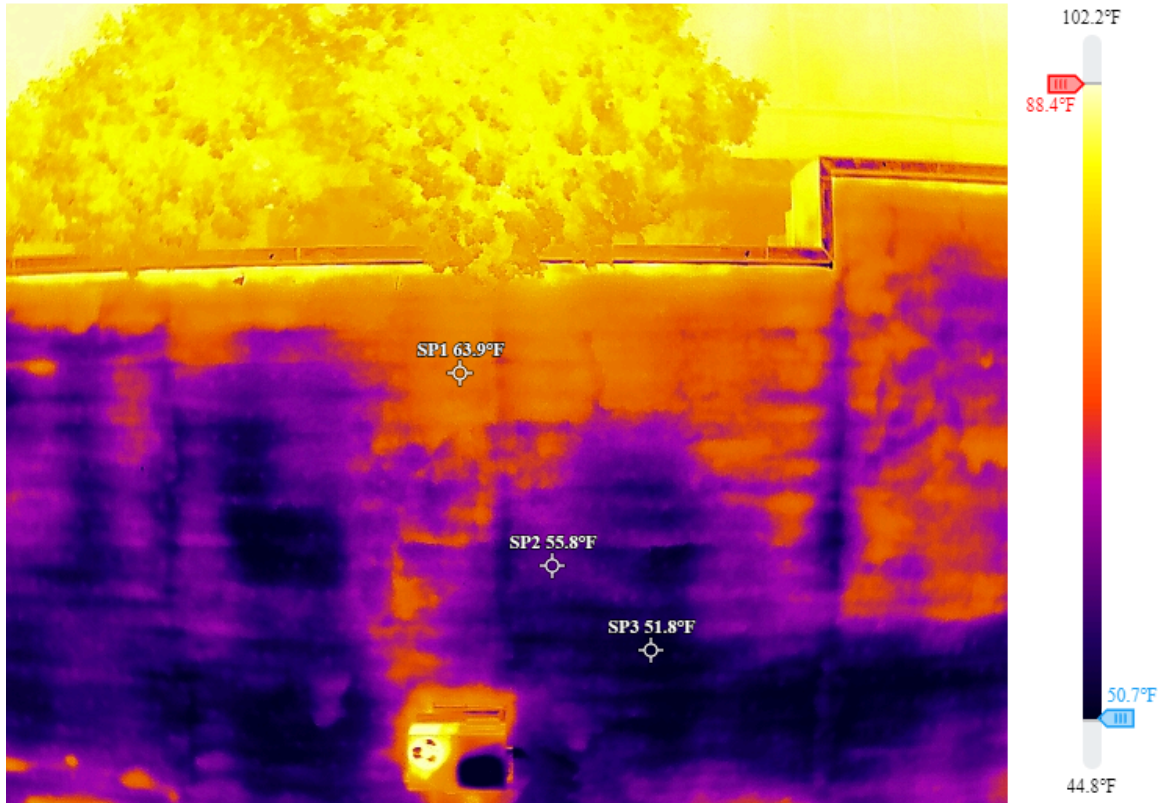
East 1.JPG

SP1	VALUE	63.9°F
SP2	VALUE	55.8°F
SP3	VALUE	51.8°F

KEY	VALUE
SP1	Moisture
SP2	No moisture
SP3	No moisture

Significant amount of suspected moisture concentrated along eastern edge.

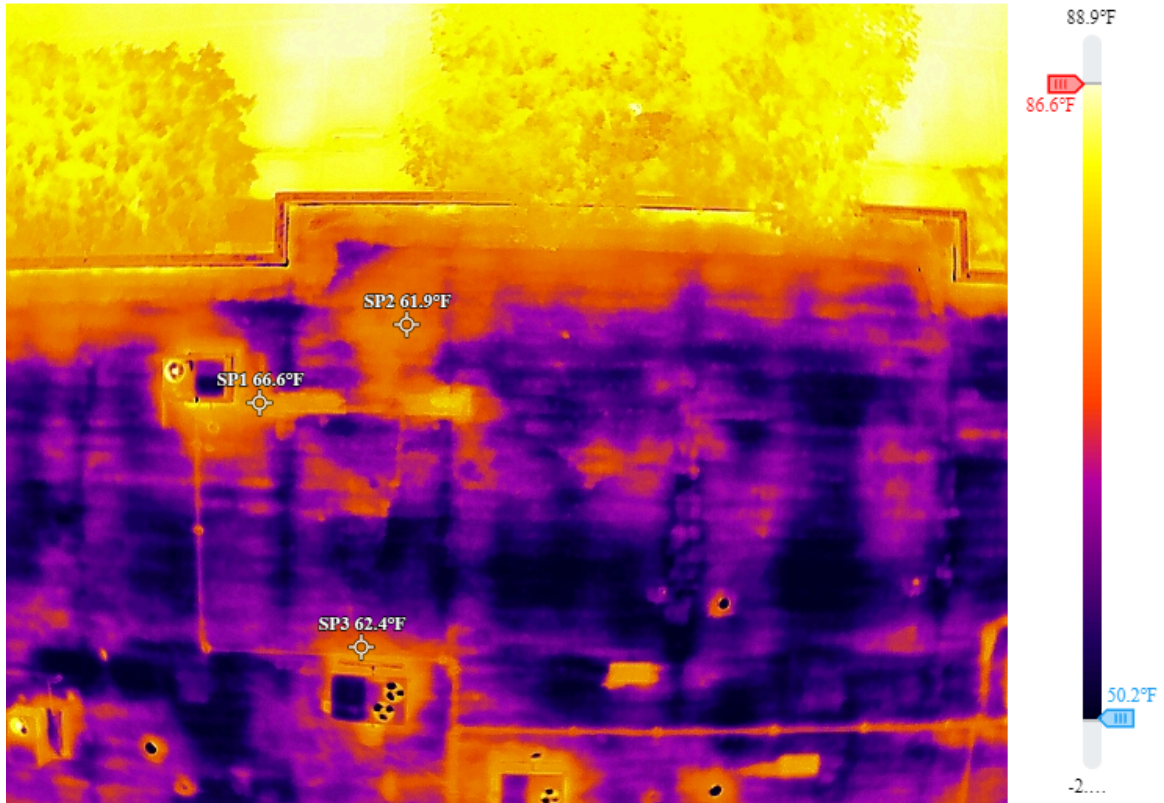
East 2.JPG

SP1	VALUE	66.6°F
SP2	VALUE	61.9°F
SP3	VALUE	62.4°F

KEY	VALUE
SP1	Moisture near HVAC

SP2	Moisture near edge
SP3	Moisture neat HVAC

Suspected moisture near HVAC units.

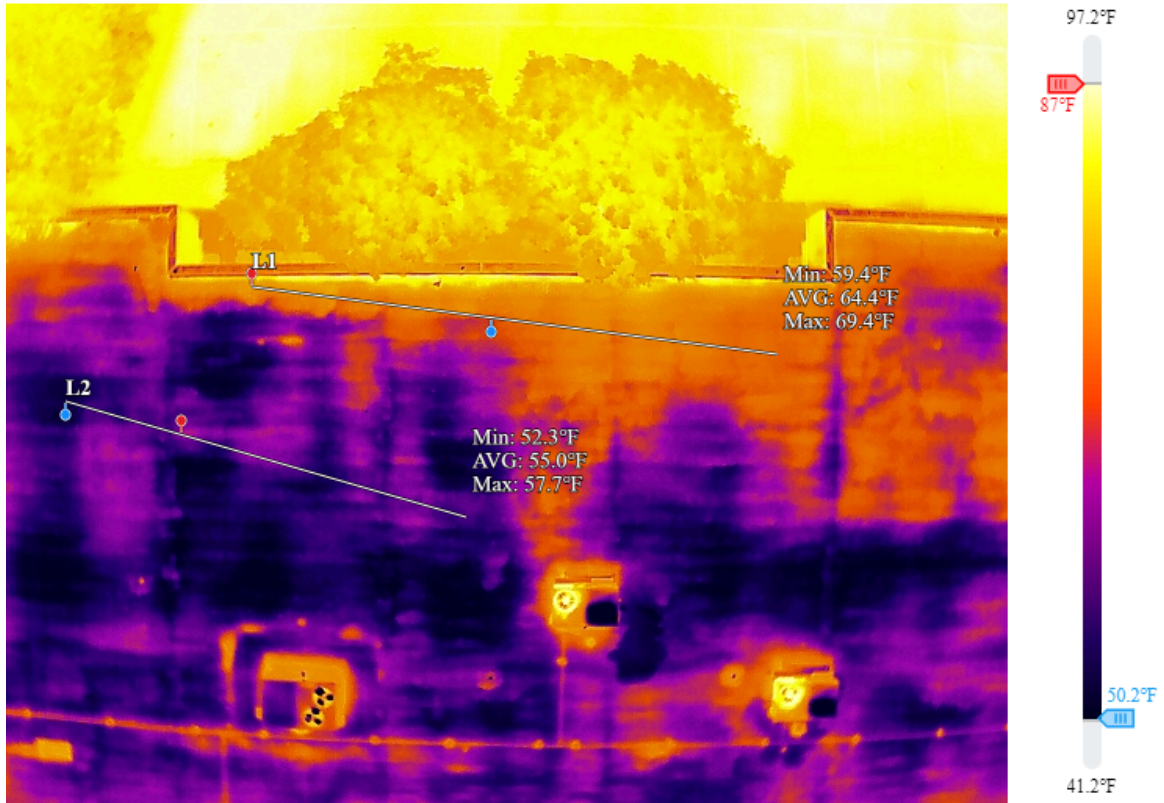
East 3.JPG

L1	MIN	59.4°F
	AVERAGE	64.4°F
	MAX	69.4°F
L2	MIN	52.3°F
	AVERAGE	55.0°F
	MAX	57.7°F

KEY	VALUE
L1	Moisture
L2	No moisture

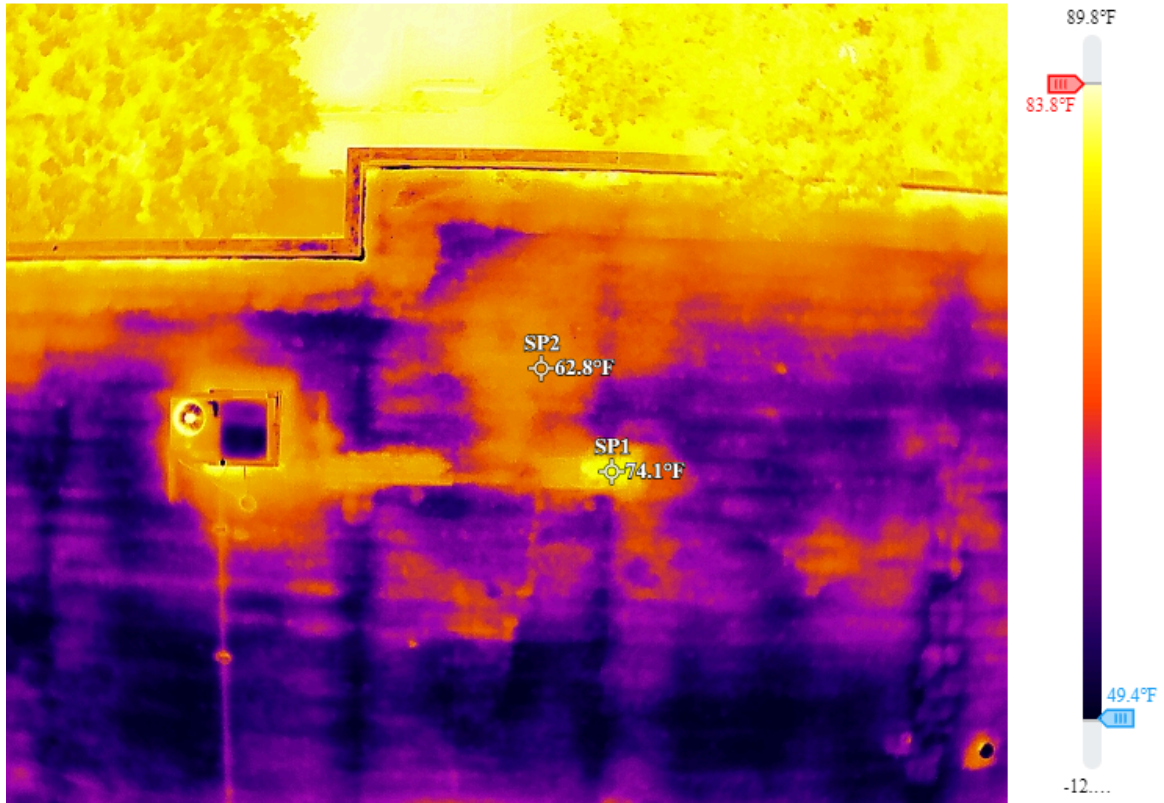
East 4.JPG

SP1	VALUE	74.1°F
SP2	VALUE	62.8°F

KEY	VALUE
SP1	Surface moisture
SP2	In-roof moisture

Due to notable temperature variation, SP1 is likely surface moisture.

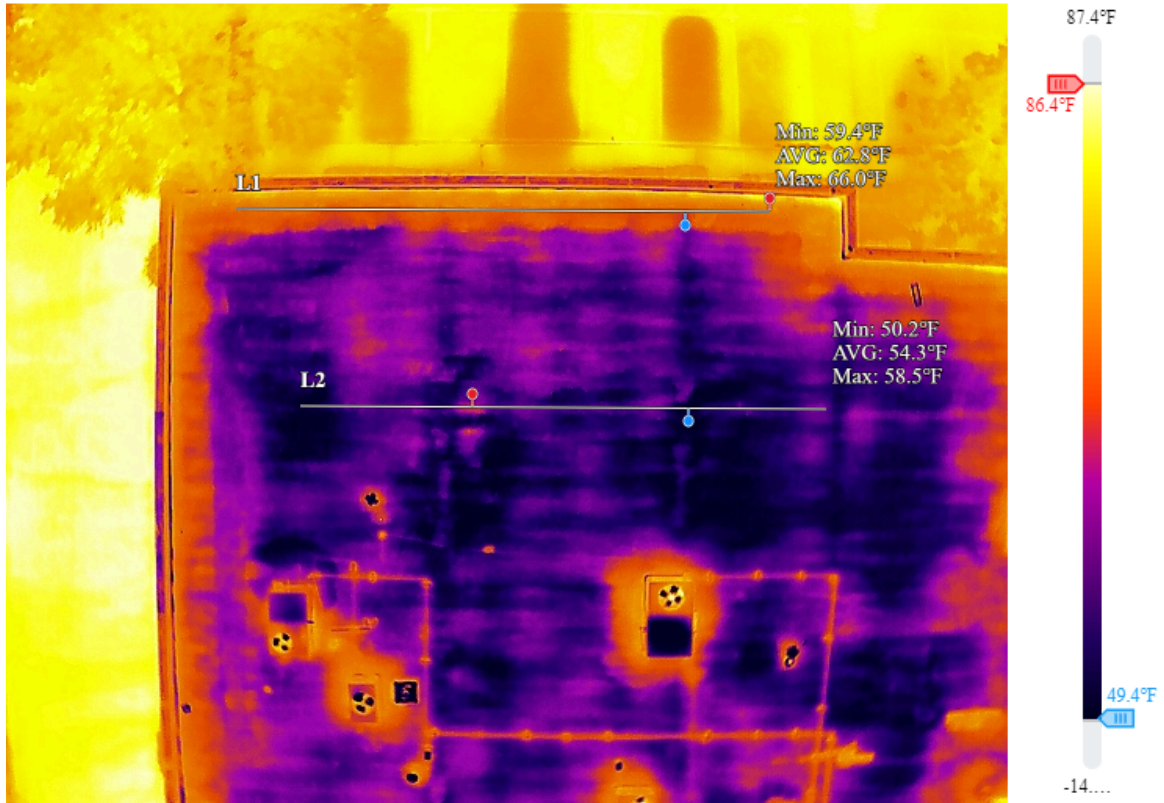
Northeast.JPG

L1	MIN	59.4°F
	AVERAGE	62.8°F
	MAX	66.0°F
L2	MIN	50.2°F
	AVERAGE	54.3°F
	MAX	58.5°F

KEY	VALUE
L1	Moisture
L2	No moisture

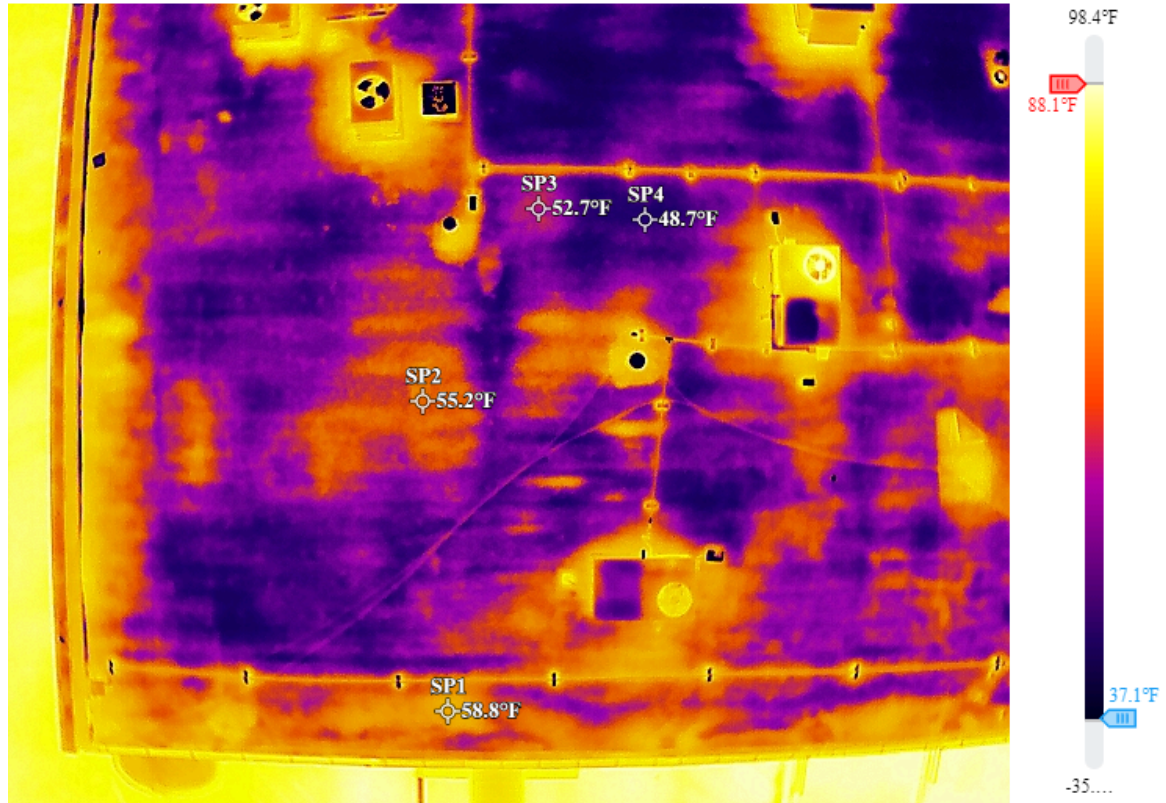
Northwest.JPG

SP1	VALUE	58.8°F
SP2	VALUE	55.2°F
SP3	VALUE	52.7°F
SP4	VALUE	48.7°F

SP1	Most moisture
SP2	Moderate moisture
SP3	Least moisture
SP4	No moisture

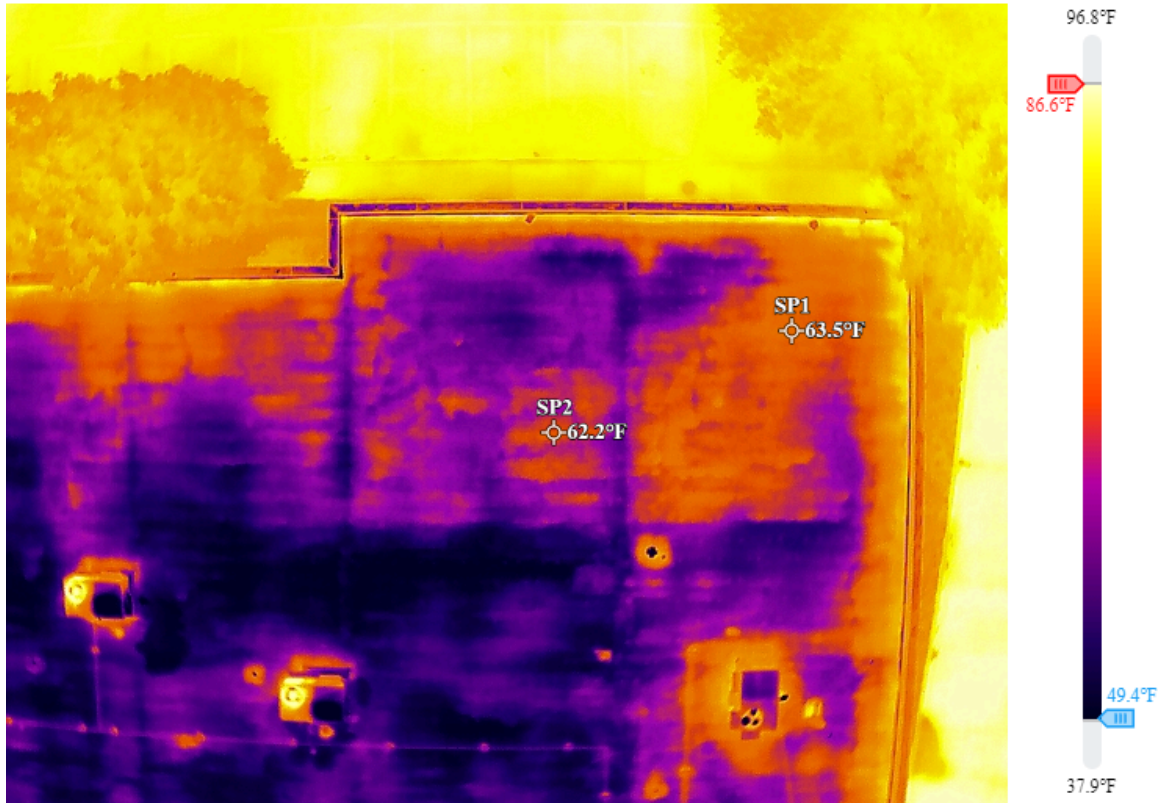
Southeast.JPG

SP1	VALUE	63.5°F
SP2	VALUE	62.2°F

KEY	VALUE
SP1	Moisture
SP2	Moisture

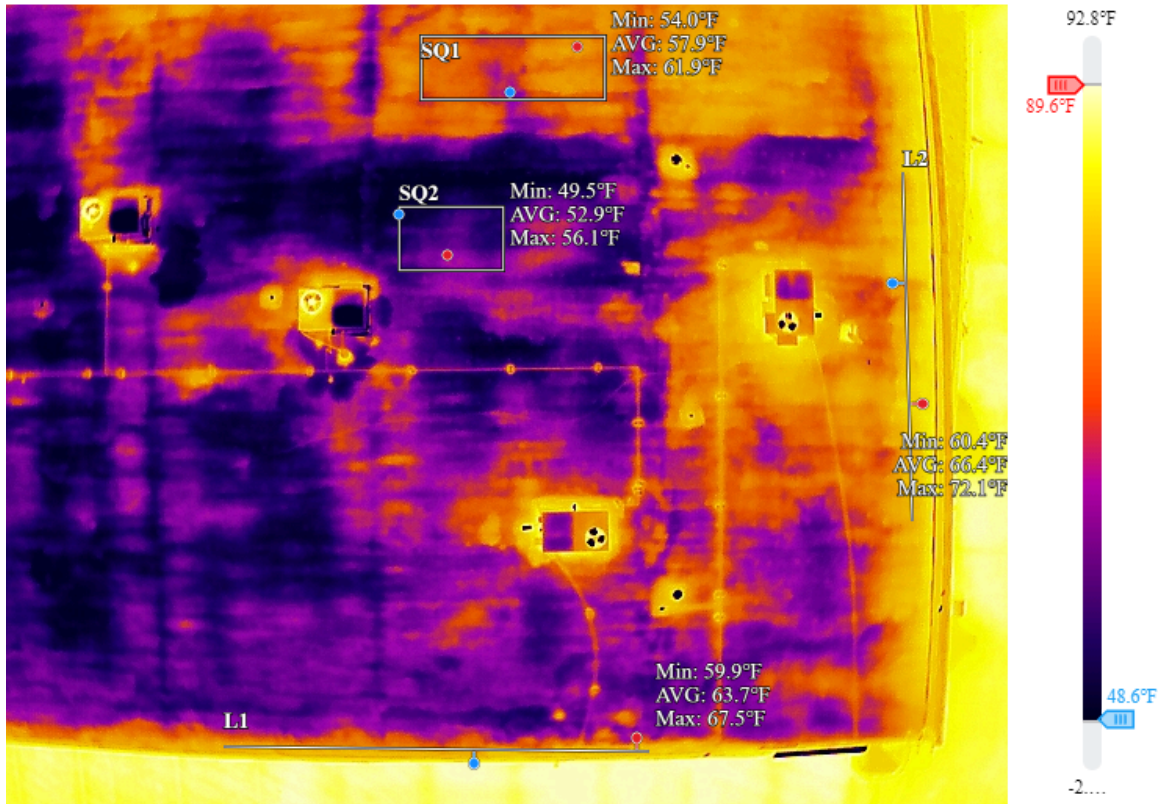
Southwest 1.JPG

L1	MIN	59.9°F
	AVERAGE	63.7°F
	MAX	67.5°F
L2	MIN	60.4°F
	AVERAGE	66.4°F

MAX	72.1°F
SQ1	MIN	54.0°F
	AVERAGE	57.9°F
	MAX	61.9°F
SQ2	MIN	49.5°F
	AVERAGE	52.9°F
	MAX	56.1°F

KEY	VALUE
L1	West edge moisture
L2	South edge moisture
SQ1	Moisture
SQ2	No moisture

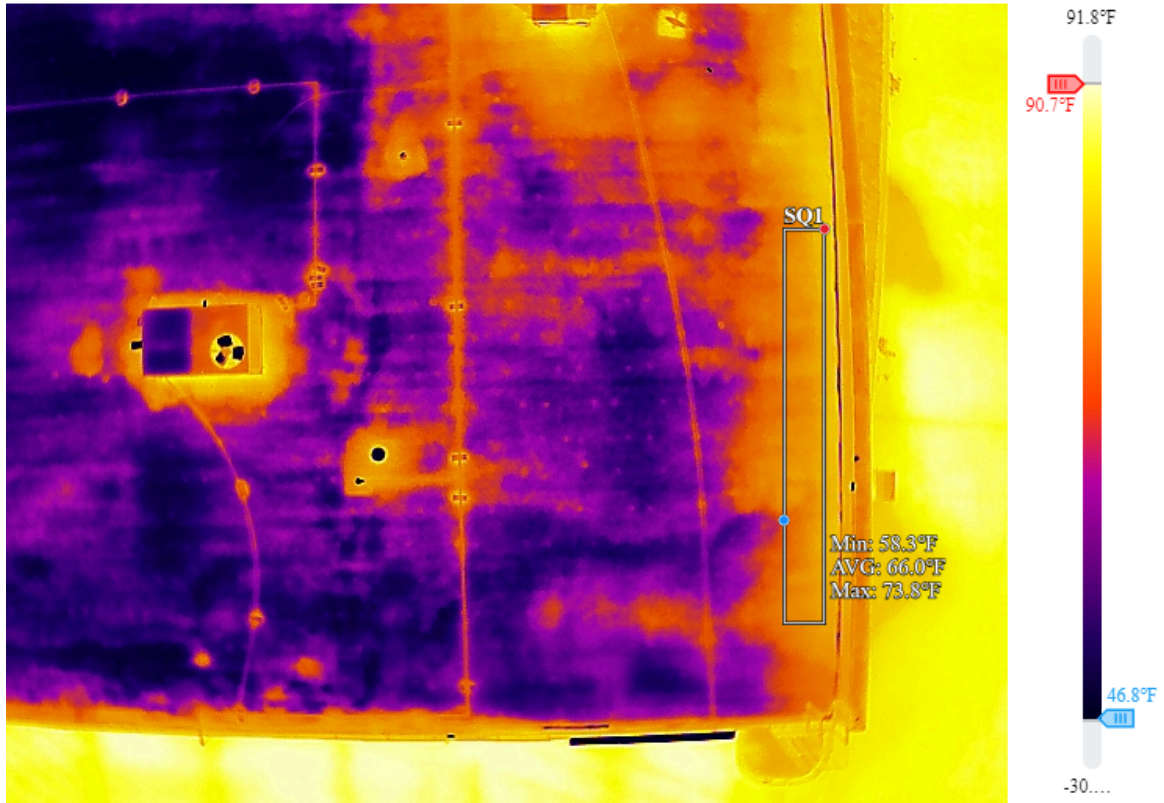
Southwest 2.JPG

SQ1	MIN	58.3°F
	AVERAGE	66.0°F
	MAX	73.8°F

KEY	VALUE
SQ1	South edge moisture

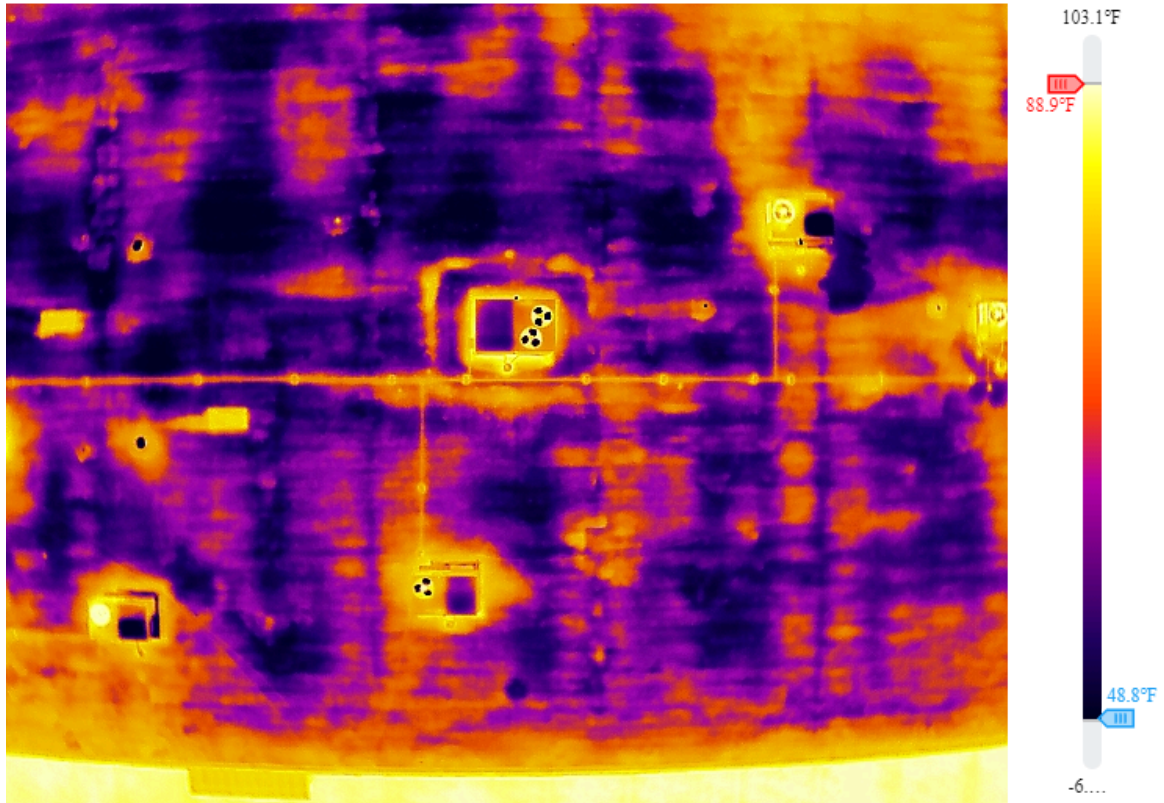
West 1.JPG

Significant indicated moisture present along western + central portions of roof.

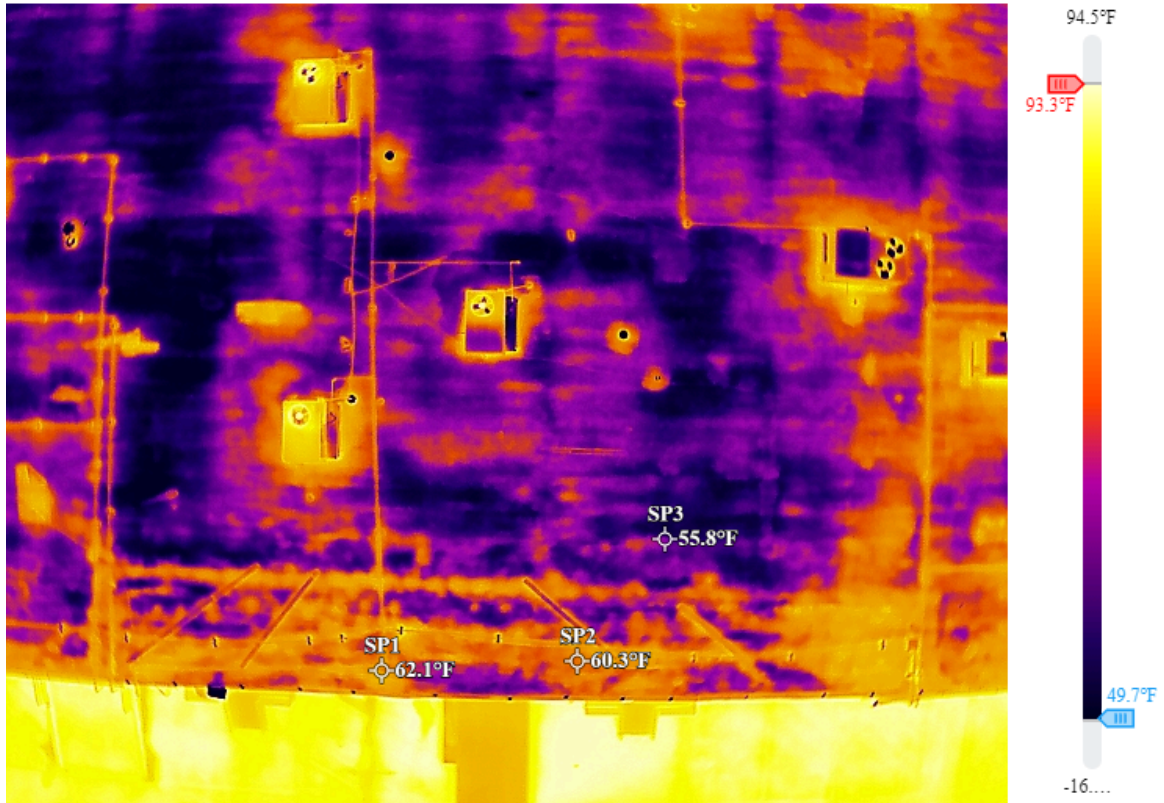
West 3.JPG

SP1	VALUE	62.1°F
SP2	VALUE	60.3°F
SP3	VALUE	55.8°F

SP1	Moisture
SP2	Moisture
SP3	No moisture

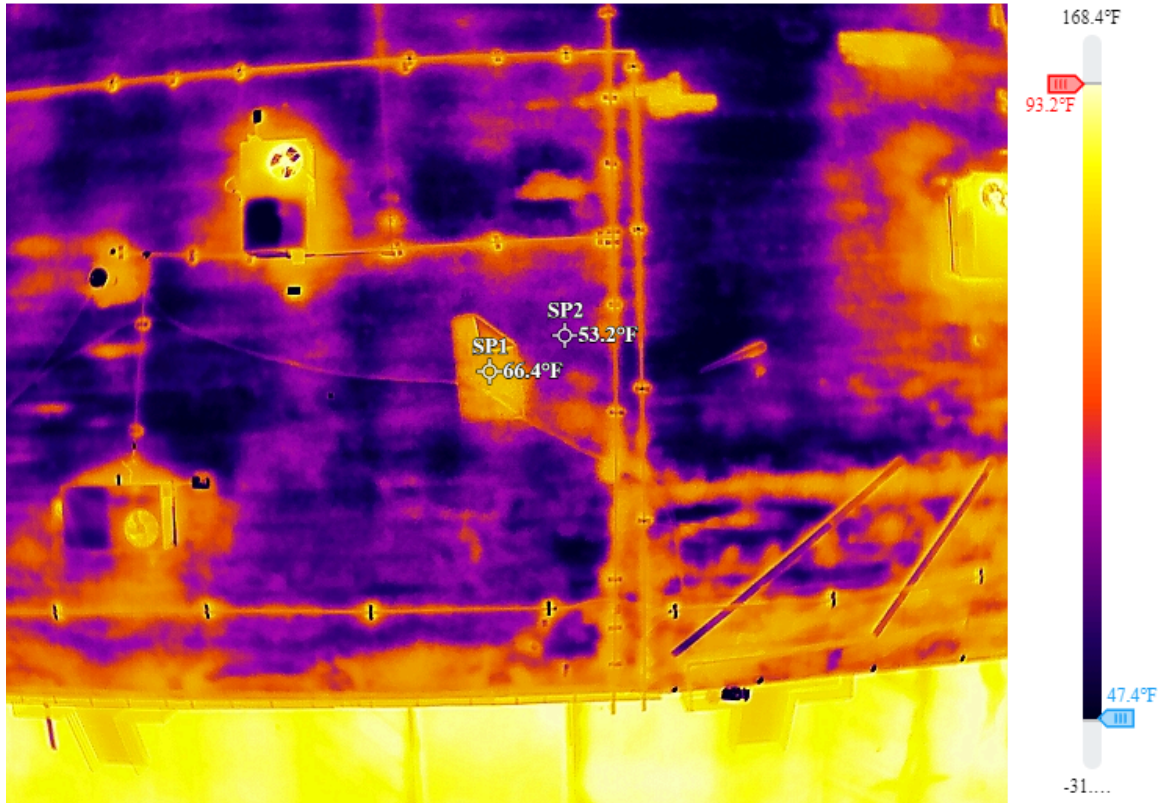
West 4.JPG

SP1	VALUE	66.4°F
SP2	VALUE	53.2°F

KEY	VALUE
SP1	Moisture/suspected damage
SP2	No moisture

Suspected surface damage/defect marked with SP1.

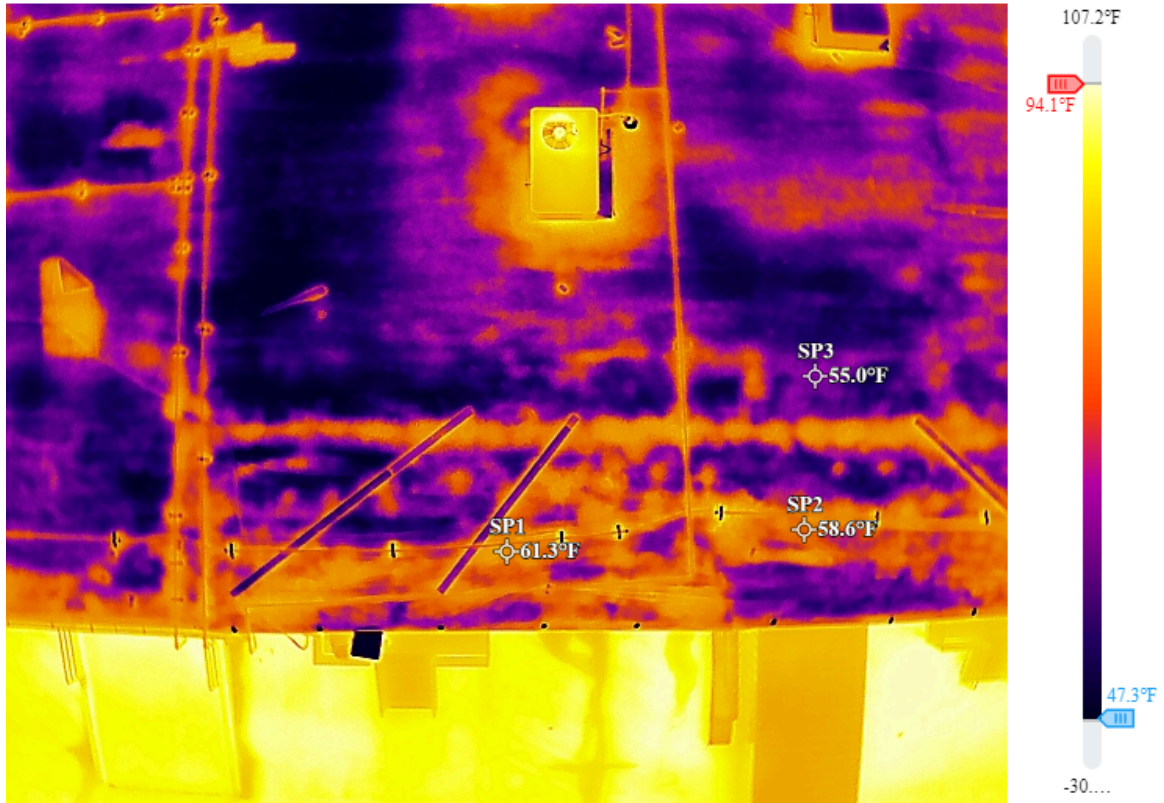
West 5.JPG

SP1	VALUE	61.3°F
SP2	VALUE	58.6°F
SP3	VALUE	55.0°F

KEY	VALUE
SP1	Moisture

SP2	Moisture
SP3	No moisture

Significant amount of suspected moisture ingress on western side of roof co-located with suspected visible damage.

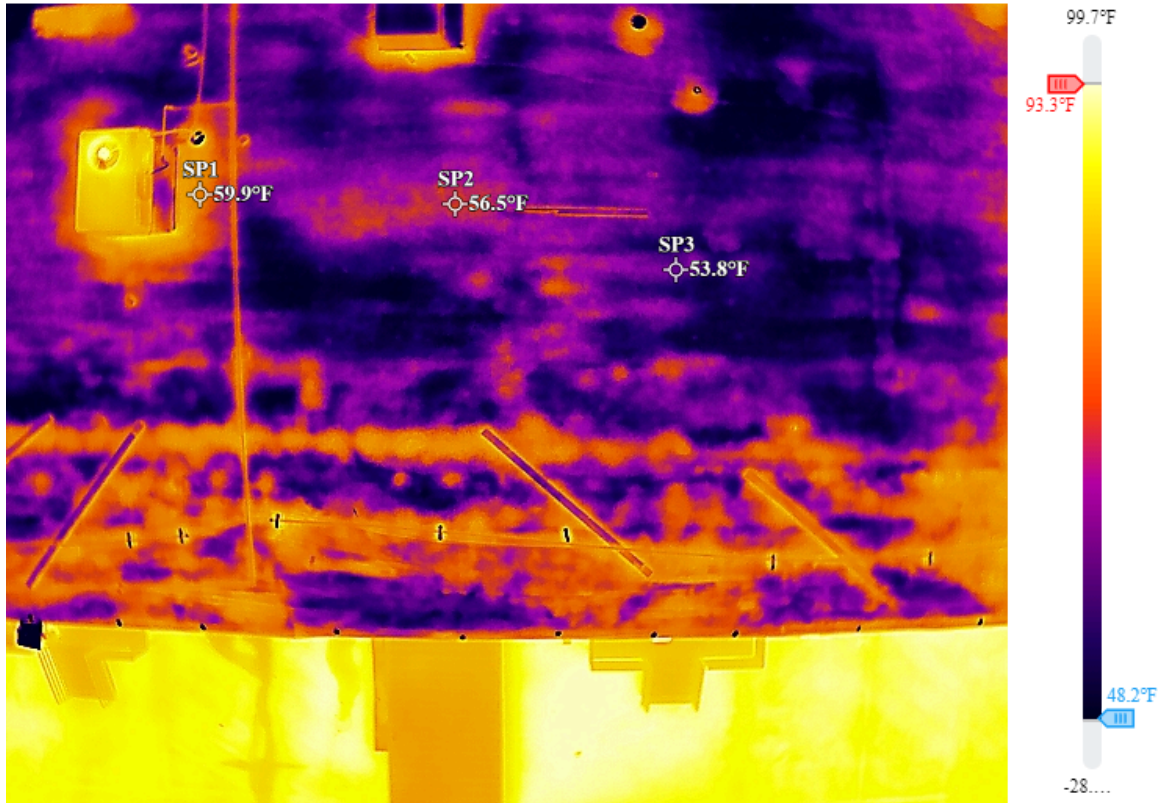
West 6.JPG

SP1	VALUE	59.9°F
SP2	VALUE	56.5°F
SP3	VALUE	53.8°F

KEY	VALUE
SP1	Moisture

SP2	Less moisture
SP3	No moisture

Suspected moisture ingress indicated past western side into the central portion of the roof.

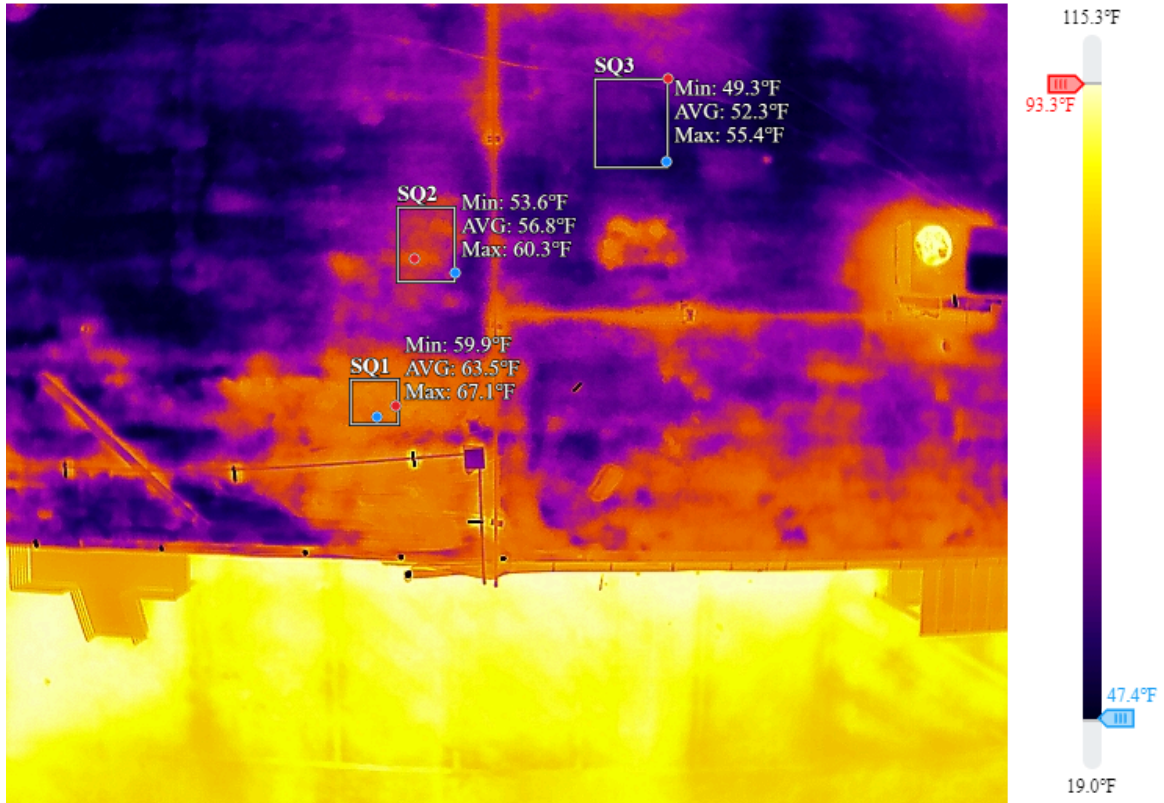
West 7.JPG

SQ1	MIN	59.9°F
	AVERAGE	63.5°F
	MAX	67.1°F
SQ2	MIN	53.6°F
	AVERAGE	56.8°F
	MAX	60.3°F

SQ3	MIN	49.3°F
	AVERAGE	52.3°F
	MAX	55.4°F

KEY	VALUE
SQ1	Most moisture
SQ2	Less moisture
SQ3	No moisture

Significant amount of suspected moisture concentrated just south of visibly damaged area along western edge of roof.
