## 3003 Swiss Ave Thermal Roof Report

### **Environmental Conditions During Inspection**

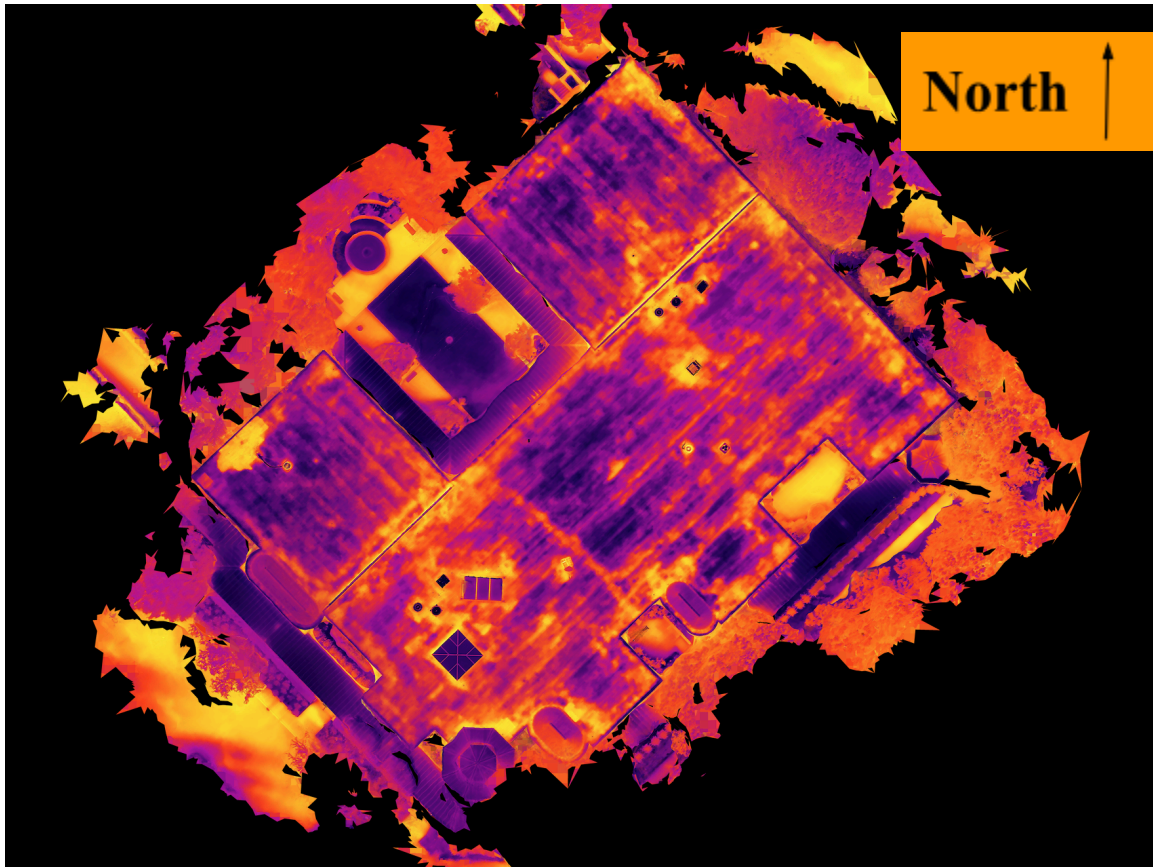
3003 Swiss Ave

Above is a 2D thermal map of the roof. This map is comprised of 282 individual photos that have been stitched together to create a complete map of the roof overlaid with thermal information.

Prior to evaluating the following inspection photos, this map provides a comprehensive look at the condition of the roof in its entirety in terms of suspected moisture intrusion. This map will also aid in orientation when different portions of the roof are mentioned (by file name) below.
